## **Drive Shaft Oil Seal**

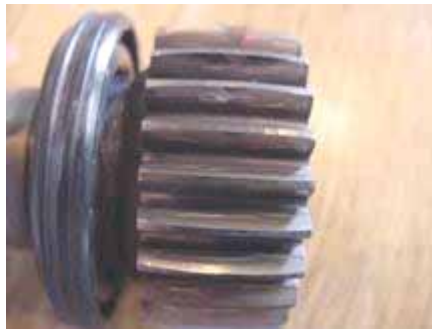
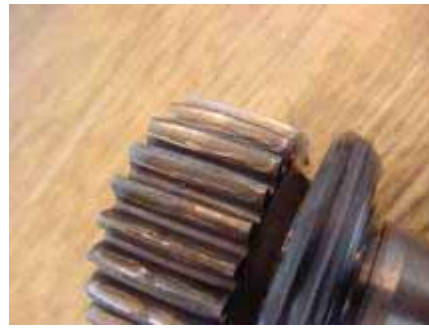
Whilst washing all the parts, the "grease" on the drive shaft's splines, turned out to be ATF mixed with the fretted material particles from the splines. It formed a paste, which blocked the two oil-feeding holes, restricting and eventually blocked the oil flow and acted as a grinding paste. This worn the drive shaft's splines, as this was the softer material of the two splines. The splines on the differential's side had no sign of wear.

*Old shaft's splines*

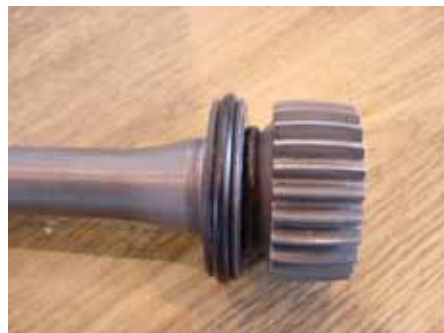
*New shaft with seal & spacer*

I used Teflon, machined a disc with a groove on the inside and outside, to accommodate two o-rings. The ID o-ring fits onto the oil seal landing on the shaft and the outside o-ring fits on the differential's oil seal landing in the input spline-cup. I spaced the seal on the driveshaft with the use of an o-ring, to get a tight fit on the washer and circlip.

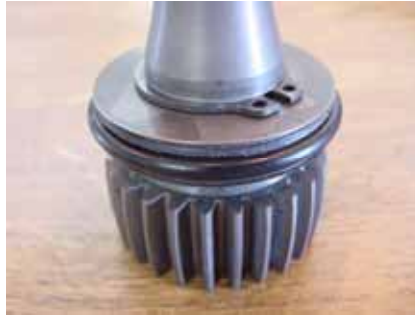
*New shaft assembly*

I replaced all the bearings on the differential according to the manual and filled it with SAE80/90 gear oil.

After that, I checked the oil level periodically, as I would order a new oil seal if necessary. It's been now 5000km later and the seal is still working perfectly - no oil lost.
